Historic Lighthouse Preservation Handbook

1997

Introduction

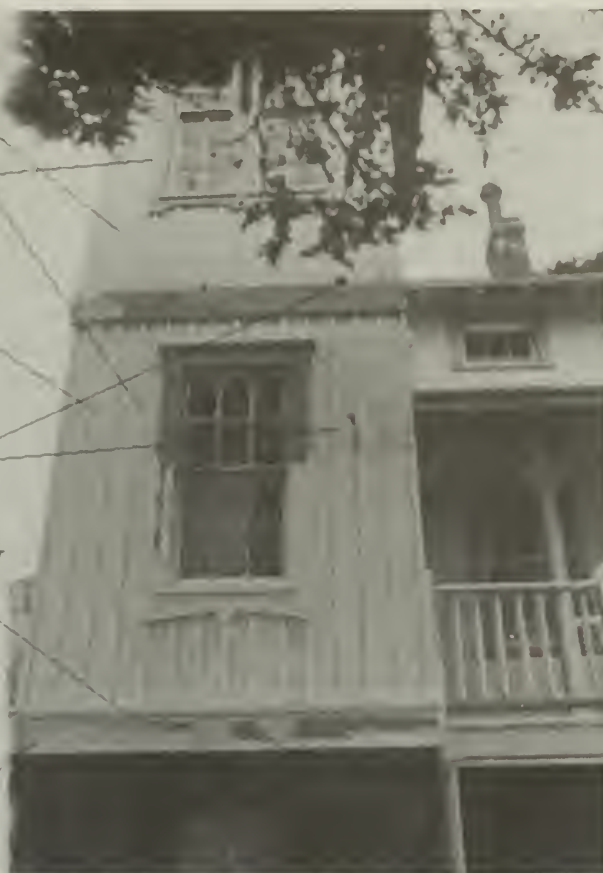
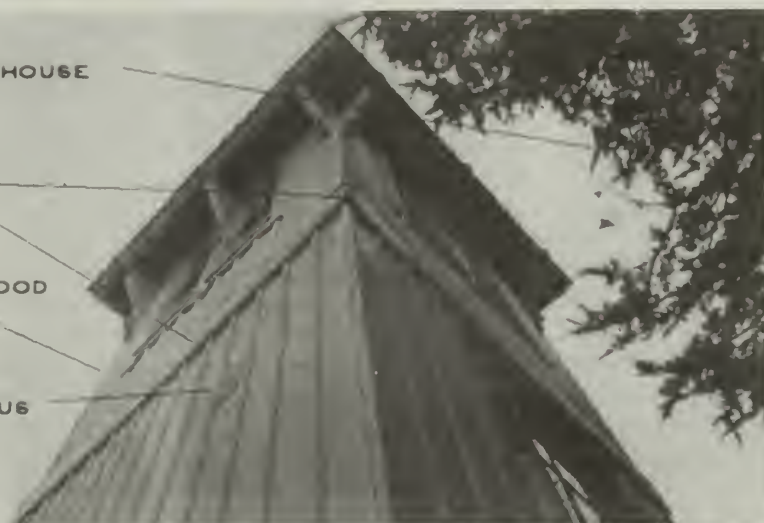
Figures 3 and 4.

CHECK FLASHING AT
WATER TABLE

CHECK JOISTS FOR
ROT WHERE THEY
REST ON THE
FOUNDATION

TREE CLOSE TO LIGHTHOUSE
TOWER

PATCHES OF BARE WOOD

EVIDENCE OF PREVIOUS
REPAIRS

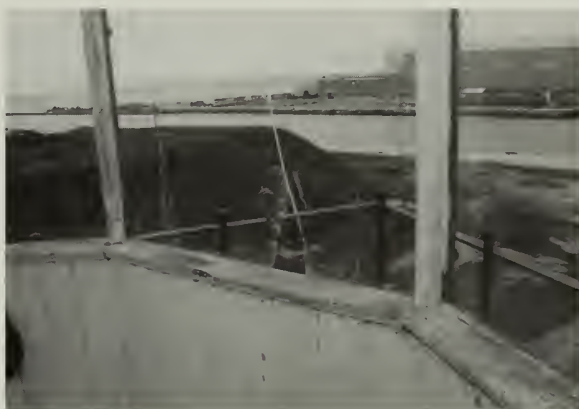
Figure 5. Storm glass with holes should be replaced as soon as possible to minimize water infiltration. If immediate replacement is not an option, the storm glass can be temporarily patched.

- **Lantern glass:** Lantern glass, frames, and roofs must be weathertight before mothballing (see Figure 5). Refer to the **Lantern** section for more information concerning the weatherproofing of the lantern components.
- **Built-in guttering systems:** All rainwater guttering systems (lantern roofs, or other tower roof forms) should be cleaned and checked for holes. Water entering the structure will cause premature deterioration of internal structural components. For more information refer to the discussion on roofing in the **Lantern** section.
- **Gallery decks:** In most wooden lighthouses gallery decks are wood covered in sheet metal. These decks are generally laid directly on top of

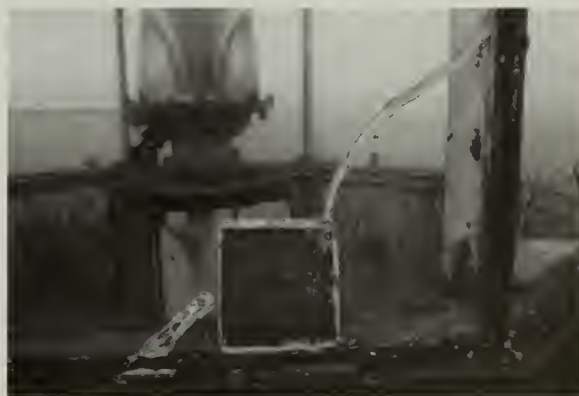
Figure 6. An acceptable temporary lantern glass repair made using a small piece of sheet metal and caulking.

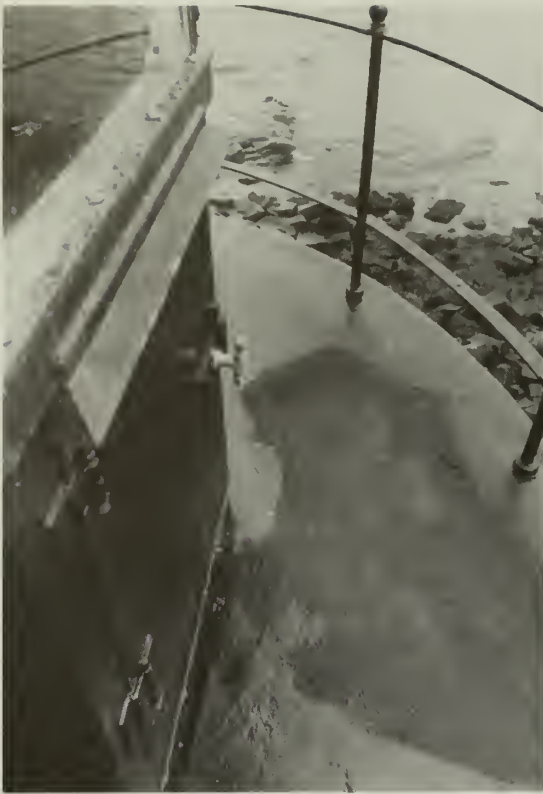
Figure 7. Ponding is occurring on this gallery deck near the base of the lantern parapet wall. This ponding has led to an active leak that occurs even during light rain conditions. A condition such as this should be remedied before the mothballing period.

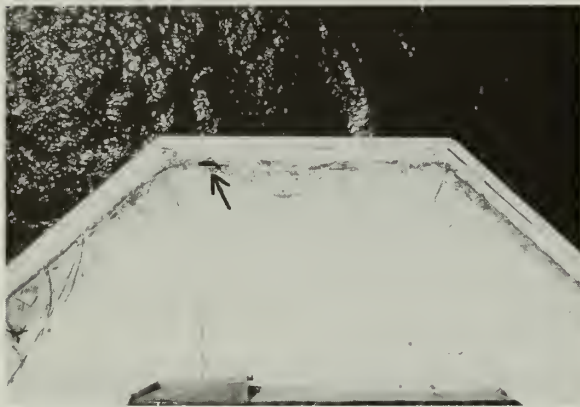
Figure 8. View of a wood-framed lighthouse roof; the arrow indicates where a large hole (approximately 2 by 4 inches) is present in the built-in gutter system. Water entering this hole has caused extensive damage to the interior wood framing members and wood interior wall paneling.

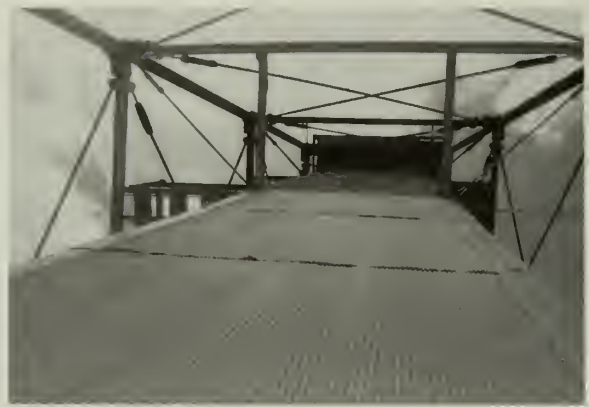
Figure 9. If the exterior of the wooden tower has been covered with another sheathing material like this corrugated metal, all joints in the exterior sheathing should be made completely weathertight; at this particular lighthouse, deterioration of interior wood framing members was caused by moisture infiltration.

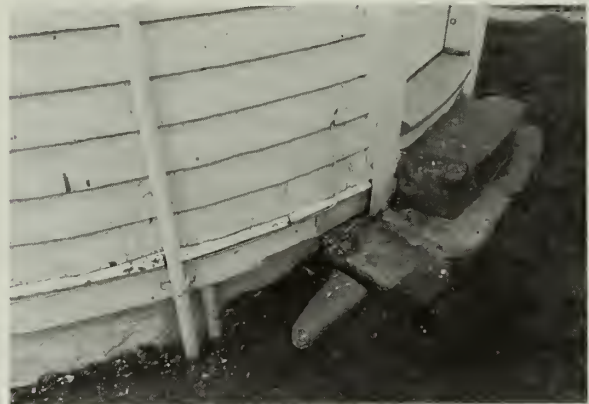
Figure 10. This door sill has a positive slope to ensure proper drainage; the joint where the door surround meets the shingles should be checked for gaps and recaulked if necessary.

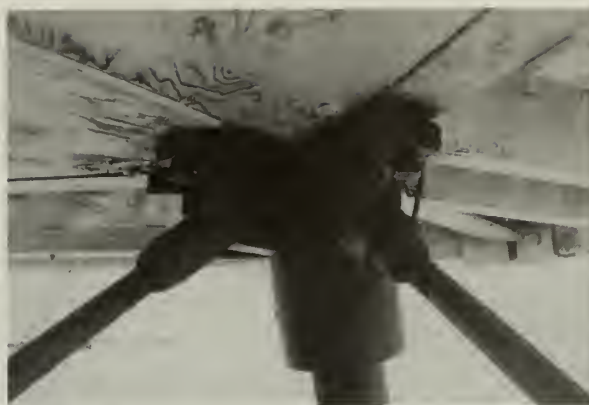
WPTC photo

Figure 12. View of underside of a screwpile lighthouse. Although these bare wood surfaces are not directly exposed to rain, they are susceptible to mist and condensation moisture; and because there is no exposure to direct sunlight, the surfaces are seldom dry. For adequate protection during the mothballing period, these surfaces should be painted.

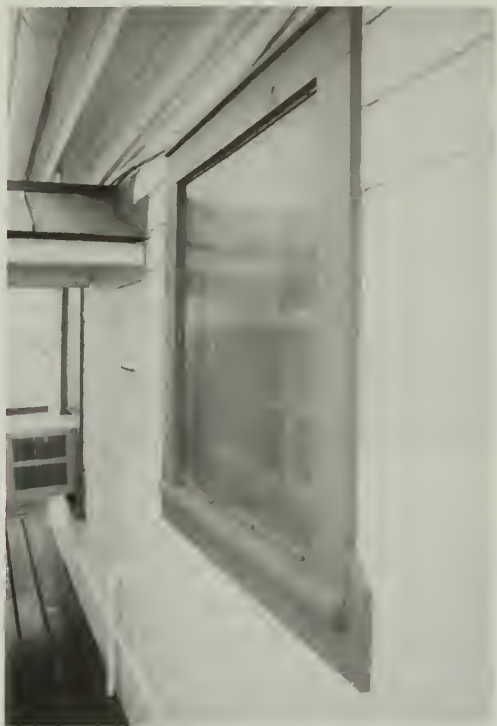
Figure 13. This image shows a Class I paint condition: virtually no deterioration, only some soiling and possible salt buildup resulting from the open-water location of the lighthouse.

Class I: Generally no paint removal—dirt, soot, pollution, chalking, mildew etc., (see Figure 13).

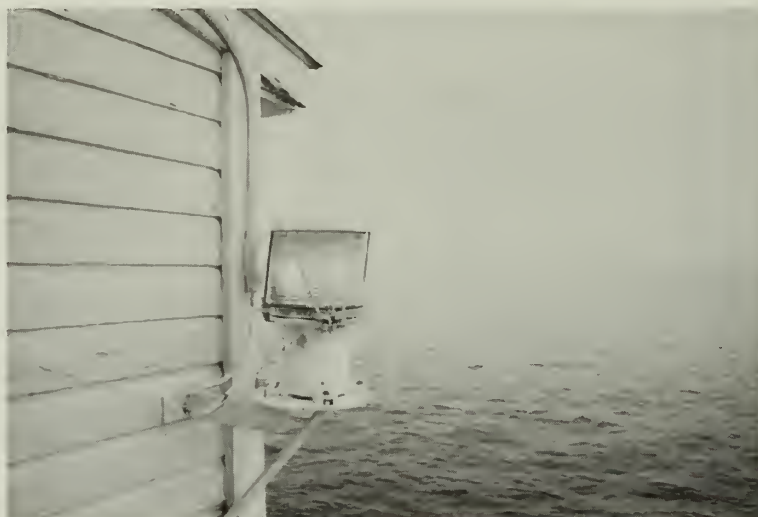
WPTC photo

Figure 14. View of Class II paint condition: this example happens to be on the same lighthouse as the Class I condition shown in the previous image; multiple paint conditions can exist on the same lighthouse. In this example, only spot paint removal and repainting will be required to remedy the condition.

Class II: Generally limited paint removal—crazing, intercoat peeling, solvent blistering, wrinkling (see Figure 14).

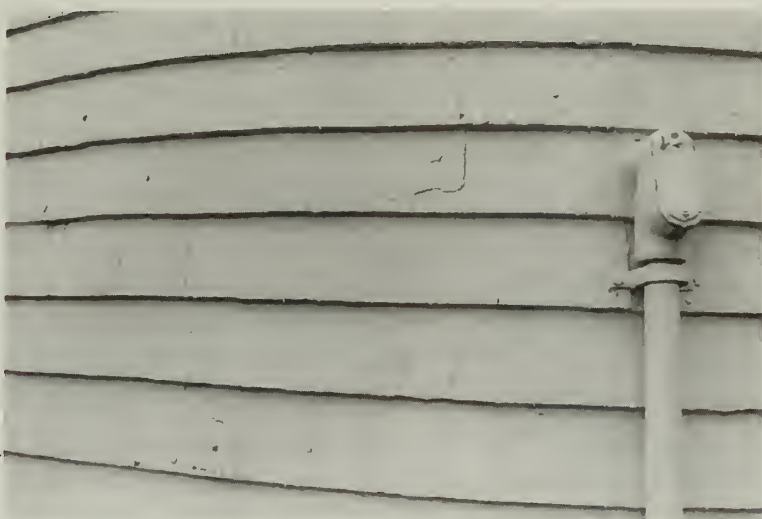
Figure 15. View of Class III paint condition: in this case the cracking, peeling, and alligating have been caused by excessive paint layer build up.

Class III: Exterior surface conditions generally requiring total paint removal—peeling, cracking/alligating (see Figure 15).

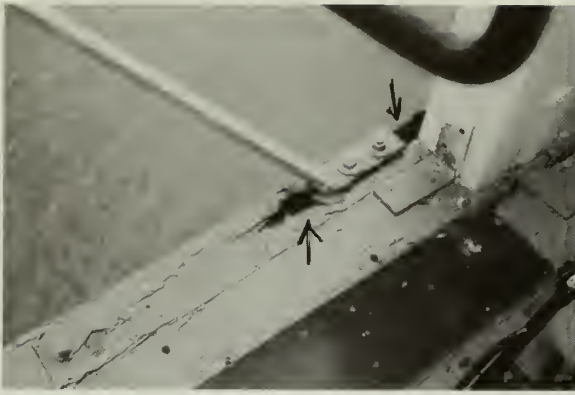
WPTC photo

Figure 18. The wooden structural member that this bracket is attached to is extensively deteriorated. This condition is a prime example of deterioration that can be repaired by cutting back the rotted wood to a sound substrate, then fitting the void created with a wooden ‘dutchman’ or infill that matches as closely as possible the grain orientation and wood species as the existing member. Once the dutchman has been glued, and if needed, doweled in place, then the affected area should be properly primed and painted. This technique is affordable and incurs only minimal damage to the existing historic materials.

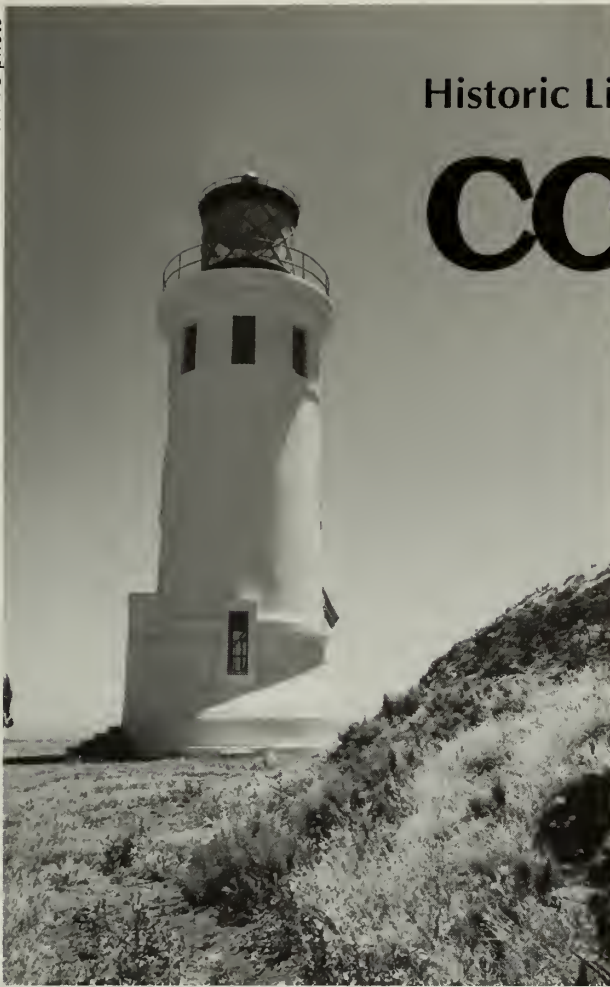
Figure 1. Anacapa Island Lighthouse is a reinforced concrete lighthouse located on a highly exposed island off the California coast. Concrete was chosen because of its ability to withstand the high winds, harsh climate, and seismic activity of this exposed location.

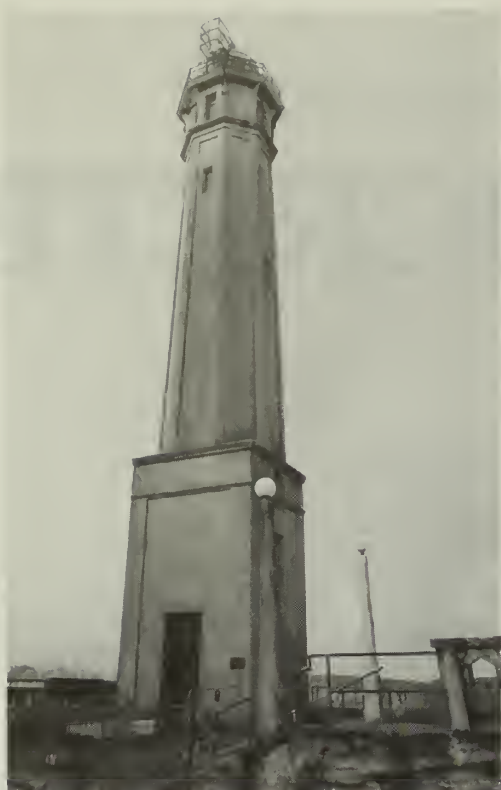
WPTC photo

Figure 2. View of the Alcatraz Island Lighthouse. Reinforced concrete was chosen for this lighthouse location for its ability to withstand earthquakes.

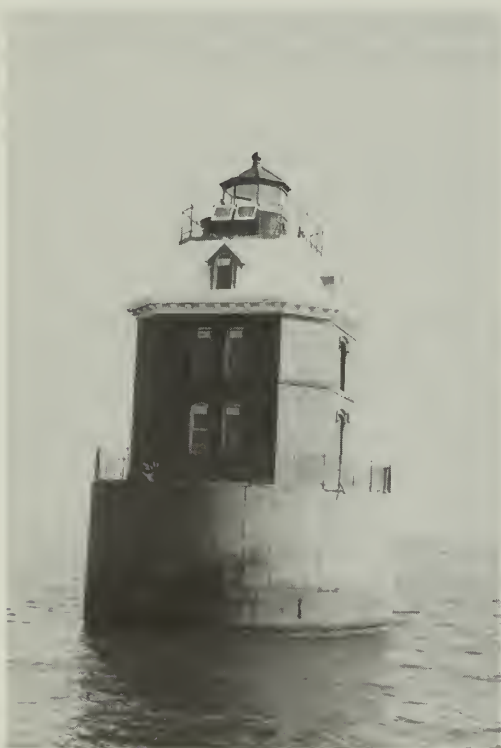
WPTC photo

Figure 3. For the construction of this caisson-style lighthouse, unreinforced concrete was used as ballast to sink the cast-iron caisson foundation deep into the mud on the bottom of the Chesapeake Bay in Maryland.

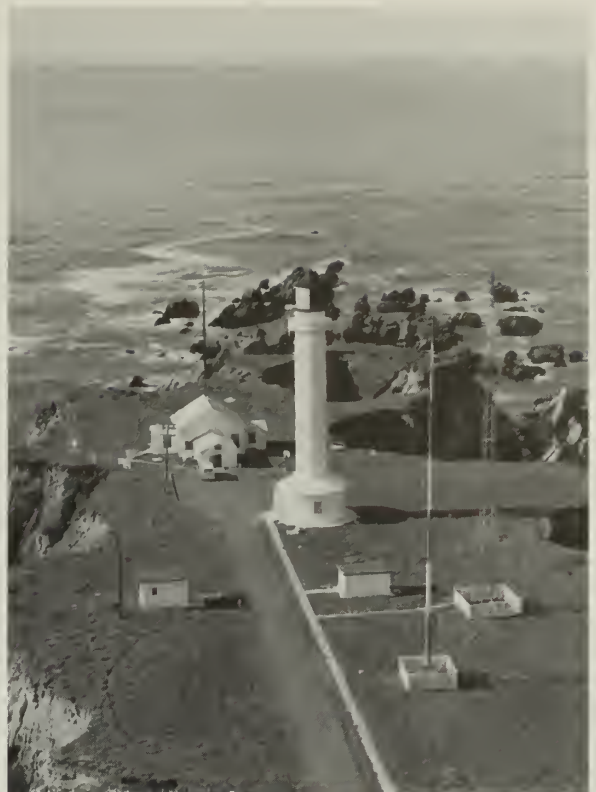
USCG photo

Figure 4. The first reinforced concrete lighthouse, Point Arena Light Station in California.

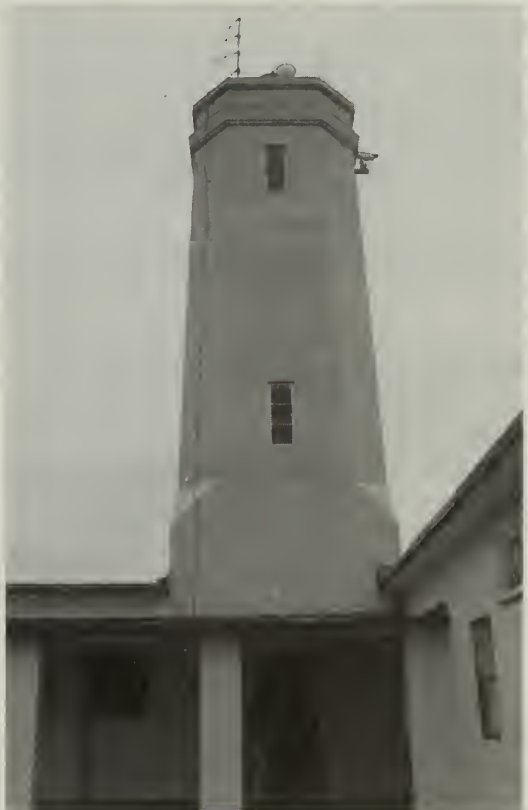
WPTC photo

Figure 5. St. John's River Lighthouse, Mayport, Florida, was constructed of reinforced concrete for its economy and low maintenance.

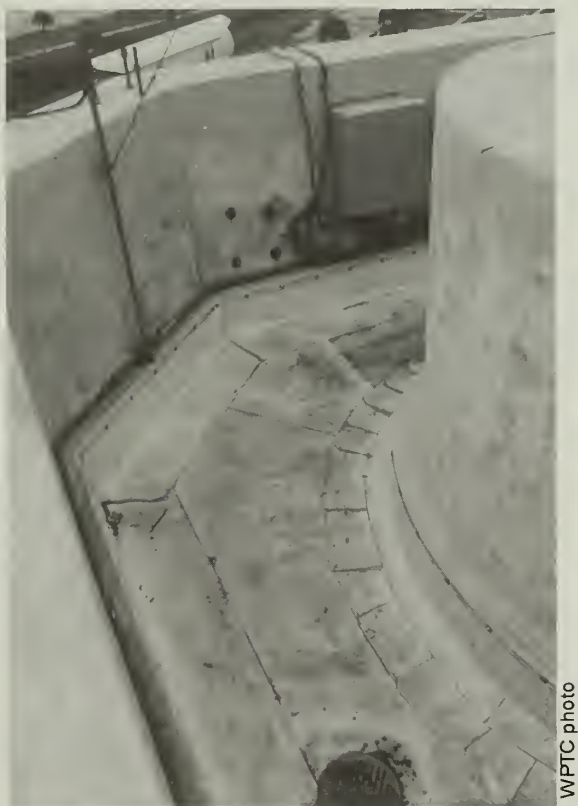
Figure 7. The concrete gallery deck on this concrete lighthouse has been covered with a rubber membrane. This covering should be checked regularly for leaks.

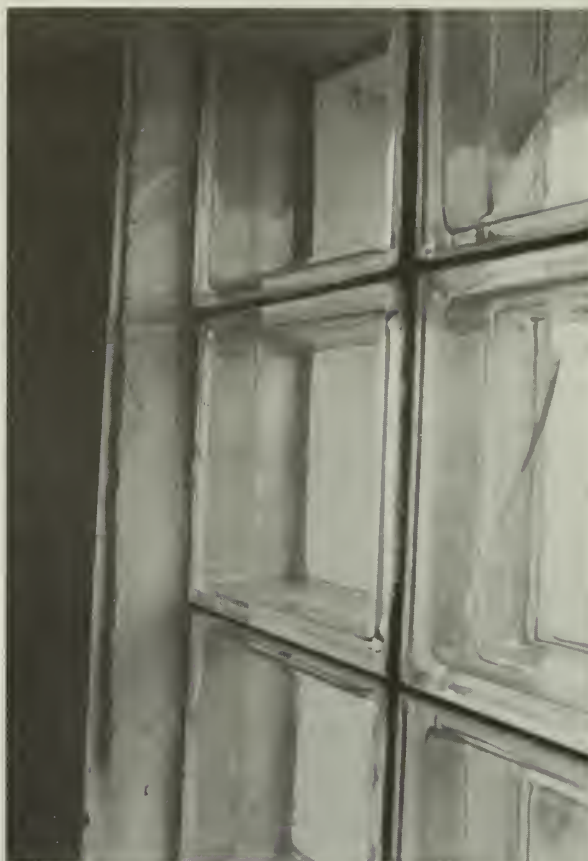
Figure 8. Close-up view of a glass-block window in a concrete lighthouse. The joint where the glass block meets the concrete wall should be caulked to prevent moisture infiltration.

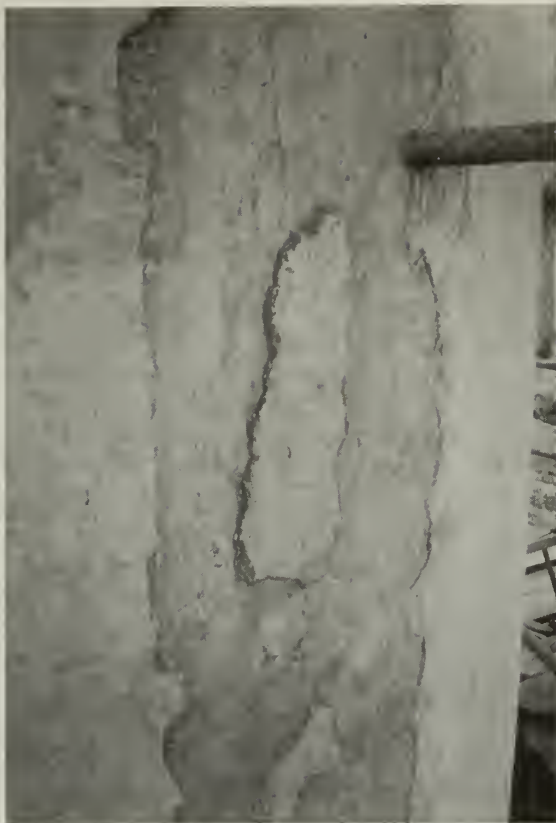
WPTC photo

Figure 9. Patches of spalled concrete: familiar with lighthouse preservation the one pictured here should be repaired to protect the underlying concrete structure.

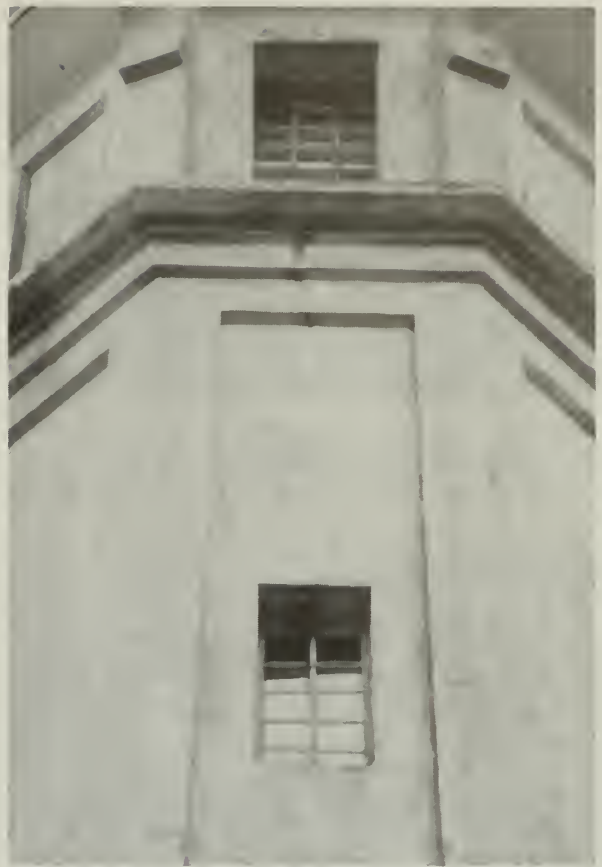
WPTC photo

Figure 10. Cracks like the one here, extending down from the belt course of this concrete lighthouse, should be monitored for movement before any patching is performed.

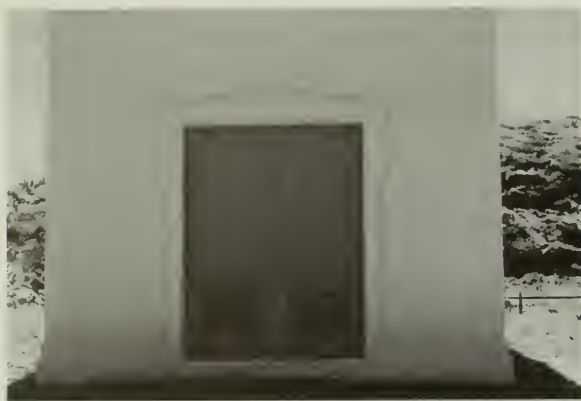
Figure 11. These replacement lighthouse doors have screened louvers that cover approximately 25% of the door opening to maximize air exchange.

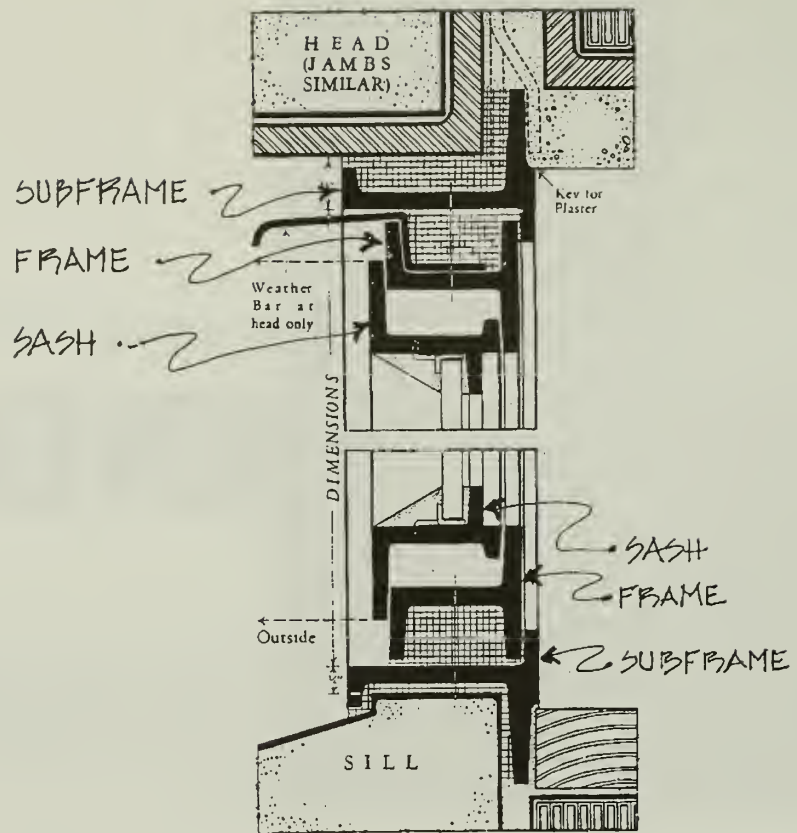
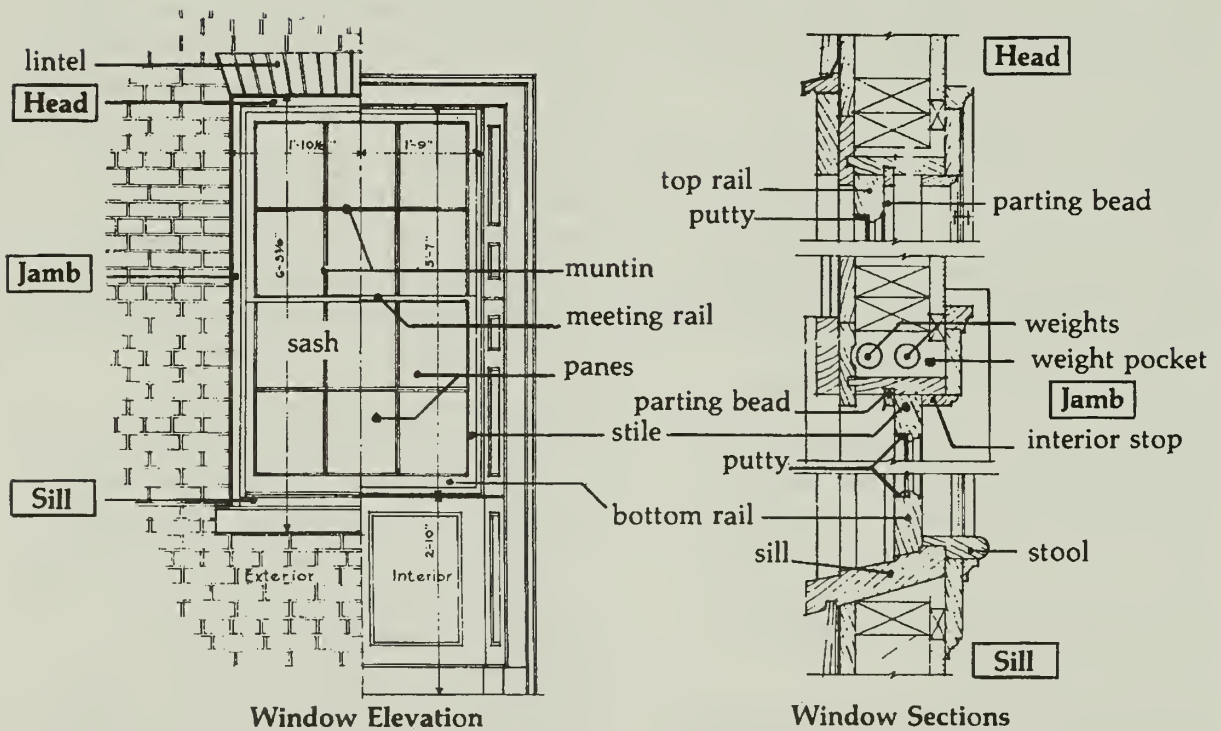
Figures 2 and 3. Wood and metal window details (source: *The Window Handbook*).

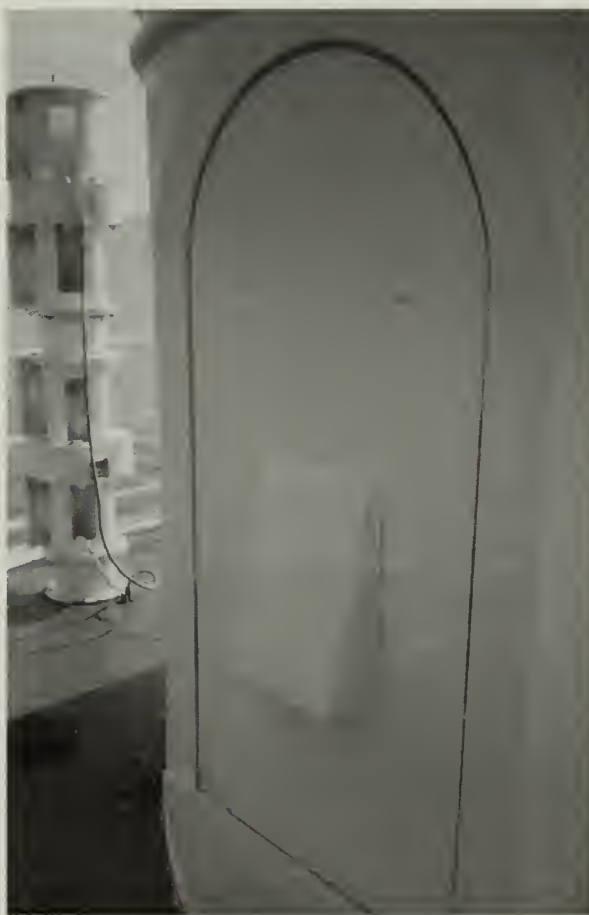
WPTC photo

Figure 4. A good example of a blocked window using a metal panel fitted with a hooded vent. For more adequate ventilation, the vent should be larger.

- There are a number of ways to insert vented plywood panels into window openings to avoid damage to frame and sash. One common method is to bring the upper and lower sash of a double-hung unit to the midpoint of the opening and then to install pre-cut plywood panels on the inside face of the window using long carriage bolts anchored into horizontal wooden bracing, or strong backs (see Figures 4 and 5).

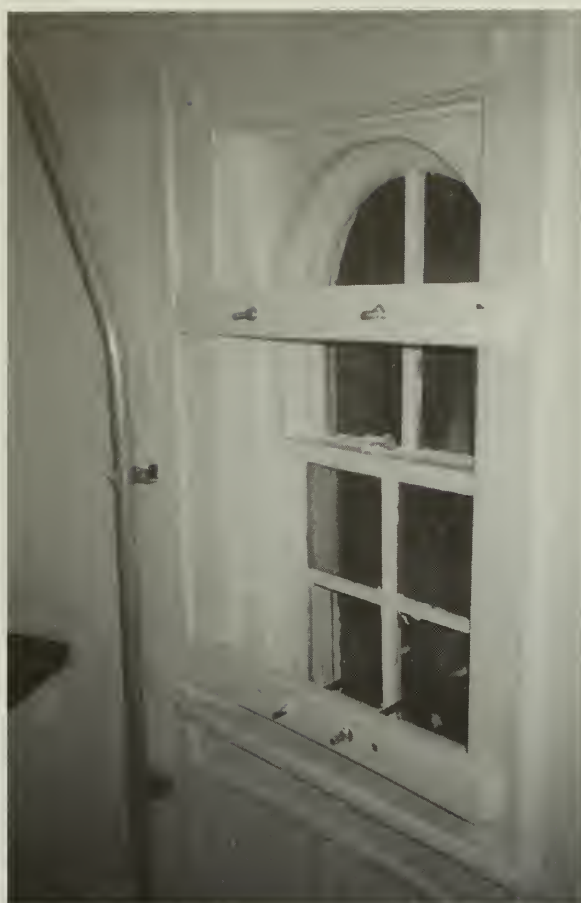
WPTC photo

Figure 5. Interior view of the blocked window. If possible, a better solution would have been to raise the lower sash and lower the upper sash and pass the bolts through the openings.

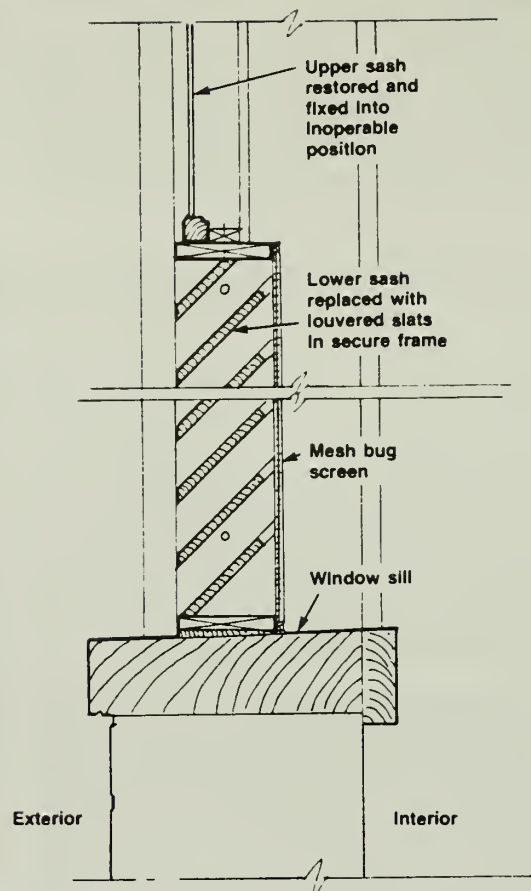
Figure 6. Detail of wood louver system designed to be inserted into lower sash opening after sash has been carefully removed. (Drawing by Thomas Vitanza, WPTC)

- The type of ventilation should not undermine the security of the building. The most secure installations use custom-made grills well anchored to the window frame, often set in plywood security panels. In upper-level windows vents formed using heavy millwork louvers set into existing window openings are another possibility (see Figure 6).

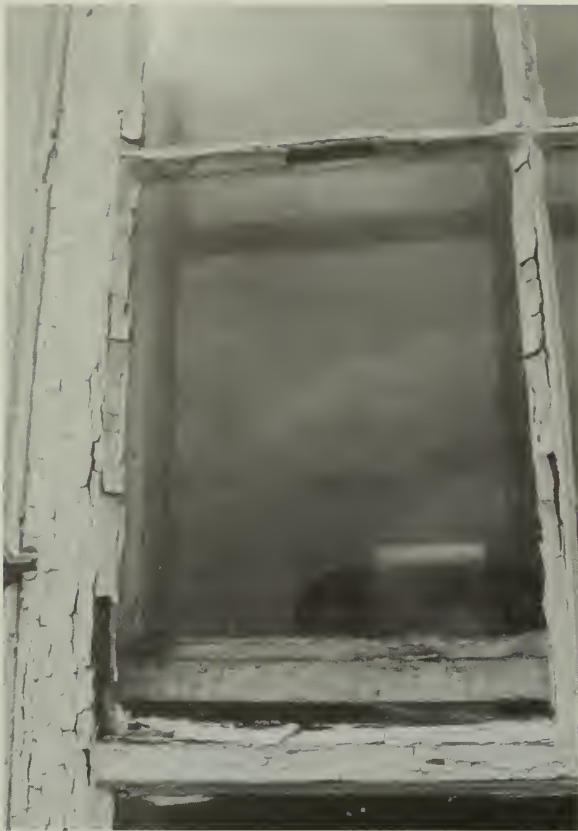
Figure 7. Deteriorated glazing putty and peeling paint on a multilite wood sash.

- Figures 7 through 9 illustrate forms of deterioration typical to lighthouse windows. All of these conditions are repairable and do not require total replacement. The following guidelines are intended to aid in the repair of such deterioration.

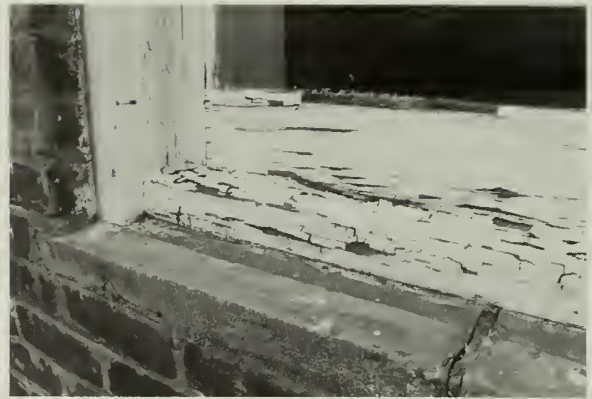
Figure 8. Deterioration of the bottom rail and sill on a wooden double-hung window.

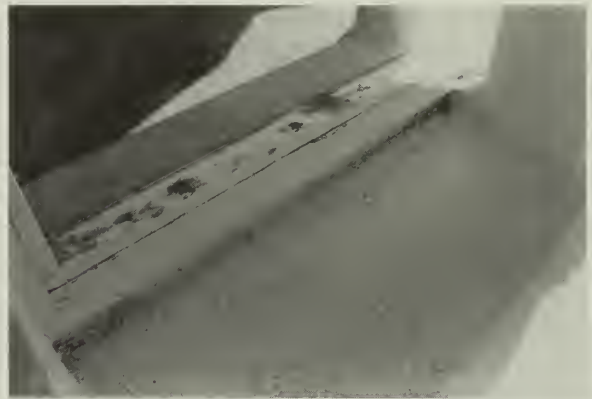
Figure 9. Rust occurring on the inside of the steel channel that forms the sill of this metal casement window.

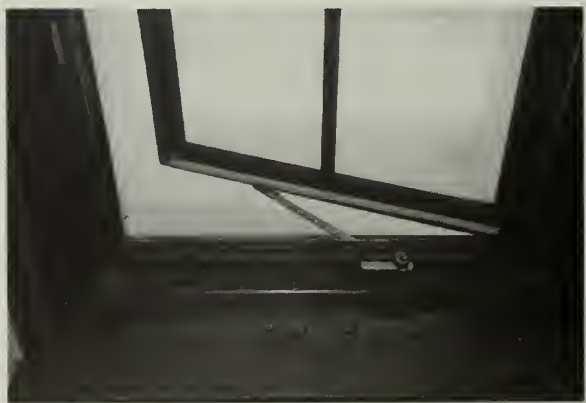
Figure 10. Close-up of a recently restored replacement metal window at Cape Hatteras Lighthouse. Now that the repair work is done, all that this window needs is the hardware lubricated and periodic maintenance to remain in operable condition for the next 50 years. At the time of this lighthouse restoration, it was discovered that the original windows were not repairable and funds were not available to replicate the original cast-iron frame design. The original windows were more like a shutter, constructed in two parts, hinged at both sides and meeting in the middle. The new landing windows were installed as a temporary measure until additional funds are available.

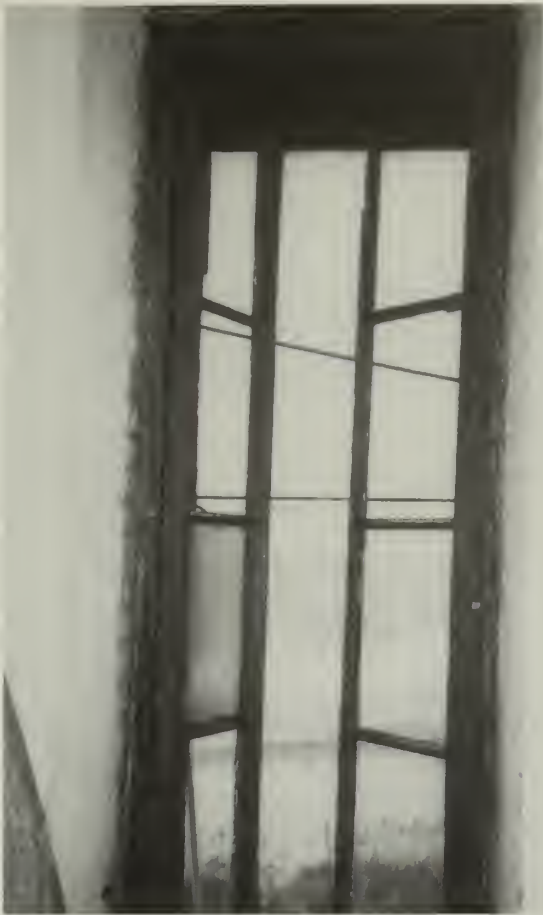
Figure 11. Example of a metal casement window in a lighthouse dating from the 1870s

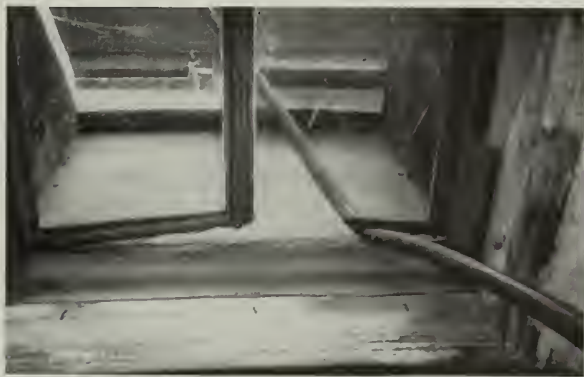
Figure 12. Close-up of severely deteriorated bottom rail of the same window in Figure 11. This condition can be repaired by splicing a new piece of sash

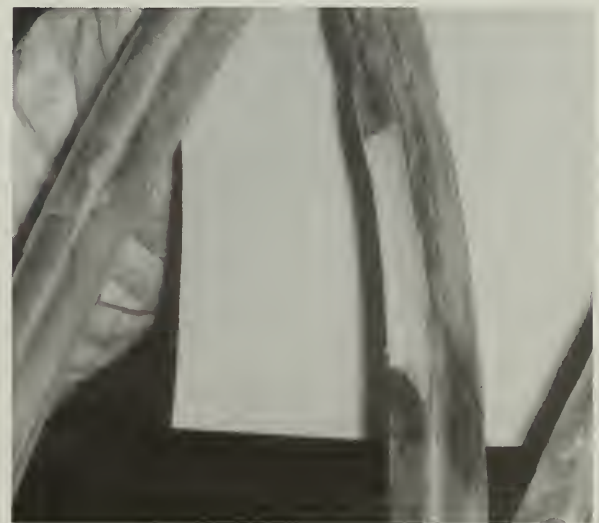
Figure 13. Close-up of a dutchman repair (light-colored wood used to mend a window muntin).

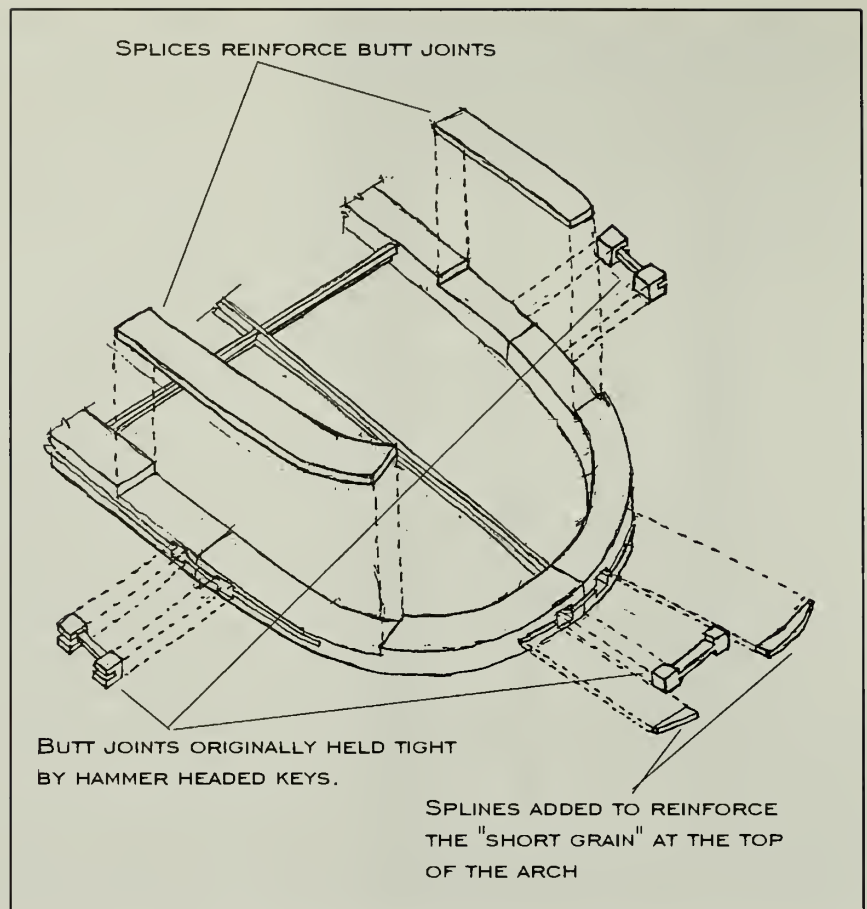
Figure 14. A wood window splice repair. (Illustration by Eric Ford, WPTC)

Deteriorated portions of wood windows can be effectively repaired using like-kind splices or dutchmen. Splicing of a wood member is required when a portion of the window, i.e., a frame rail, has been damaged or has deteriorated and only that portion needs removal and a new section attached in its place. All deteriorated material should be removed, and the end where the replacement member will be attached should be cut on a diagonal to increase the gluing surface area. The replacement member should match the existing members in grain orientation and in any existing shape or profile. The new member can even be made from matching salvaged stock. To attach the new member,

cut the end diagonally to match the existing member; then drill aligned holes in both members for reinforcing dowels.

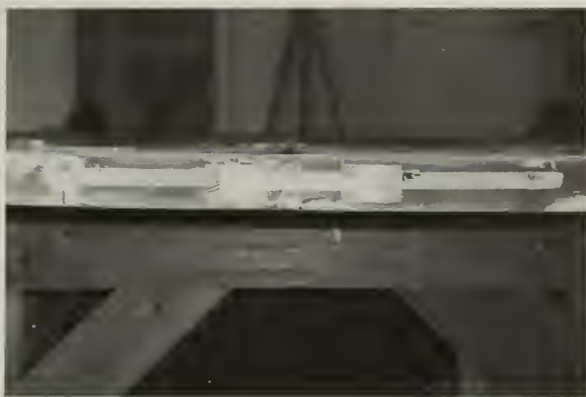
Figure 15. This window sash frame was repaired with traditional (replacement wood hammerhead key) and modern epoxy filler (material to left and right of the hammer head key) techniques.

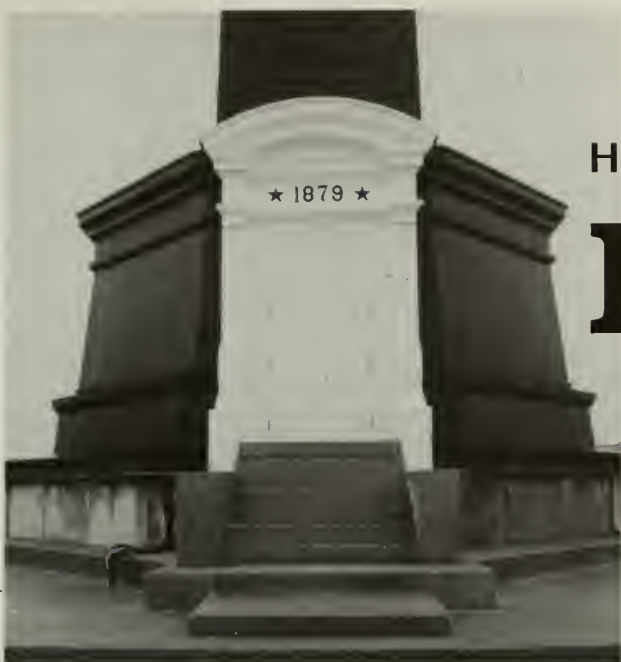
Figure 1. Close-up of large, double-leaf, wood-frame and panel doors at the Cape Henry Lighthouse (second tower), Fort Story, Virginia.

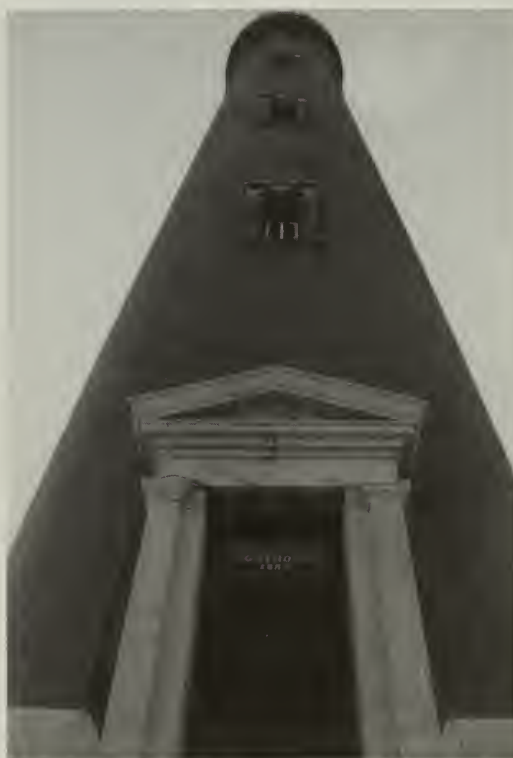
Figure 2. View of the neoclassical doorway at the Ponce De Leon Inlet Lighthouse, Florida.

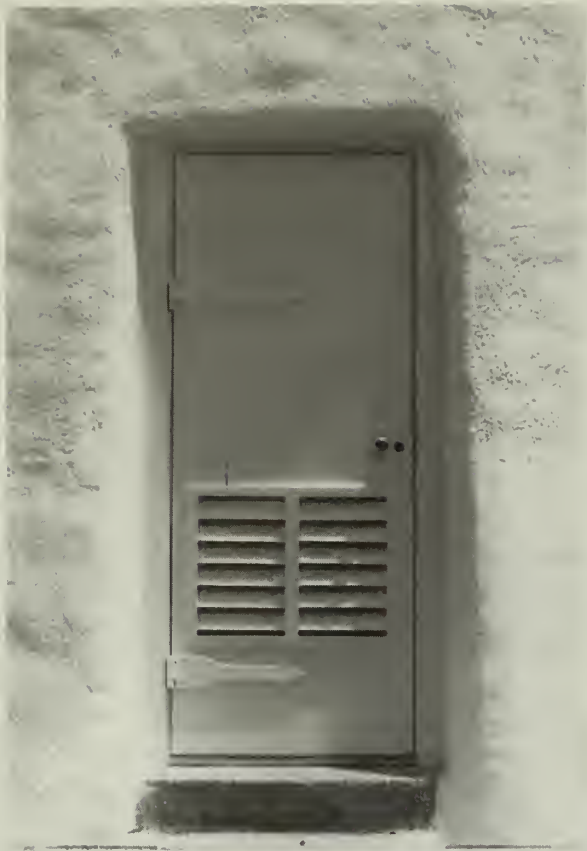
Figure 3. View of the simple pre-Civil-War-style replacement plank door at the Ocracoke Lighthouse, North Carolina.

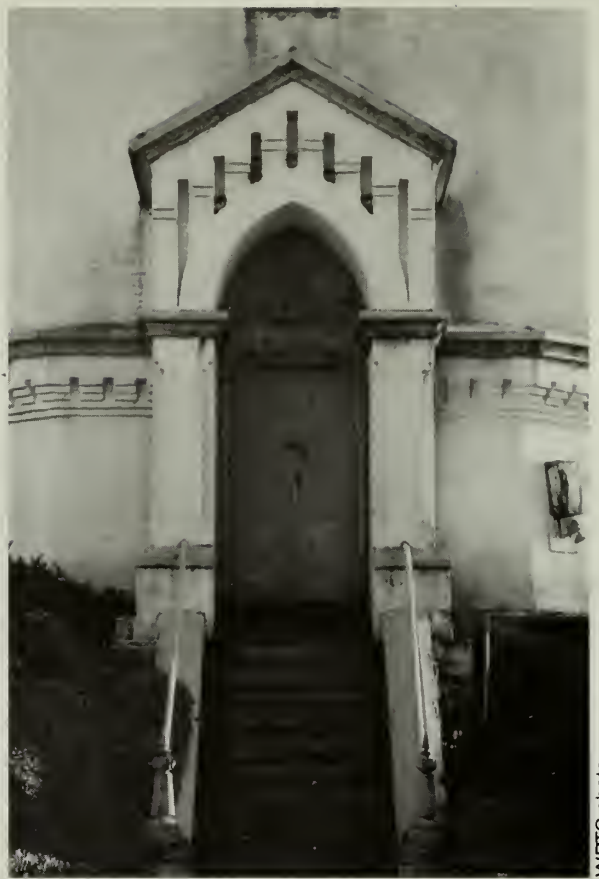
Figure 4. View of gothic revival style entrance at Piedras Blancas Lighthouse, California.

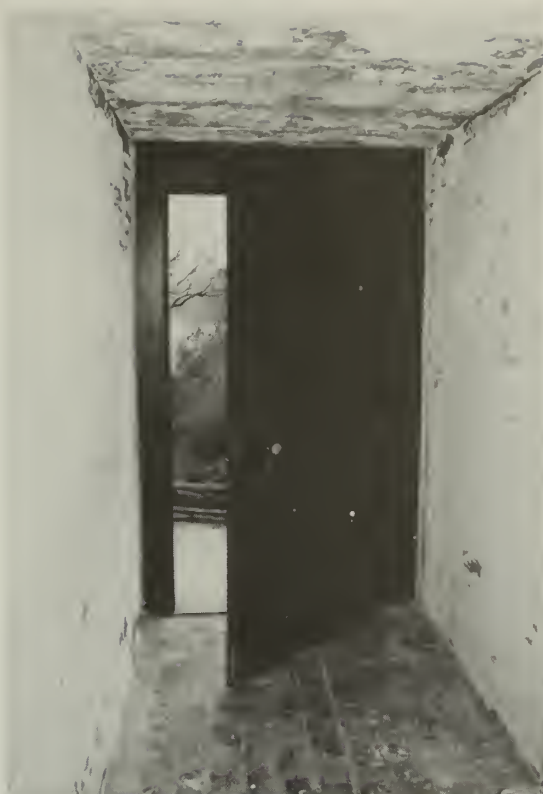
Figure 5. View of the large, single-leaf, wood-plank door at the Cape Henry Lighthouse (first tower), Fort Story, Virginia.

- **Wood plank door:** A door of one or two leaves that is constructed of two layers of tongue and groove wood planks that run vertically on the exterior side of the door, and typically run horizontally or diagonally on the interior. The planks are typically fastened by clinch nailing (nails that are driven through the outside of the door and bent over on the inside). The door is usually reinforced with horizontal 'battens' at the hinge locations: a diagonal batten may run from the top batten to the bottom batten. Such a door is typically hung on strap hinges; however, butt hinges may have been used. This construction method is used to limit the exposure of the end grain in the boards to the top and bottom of the door.

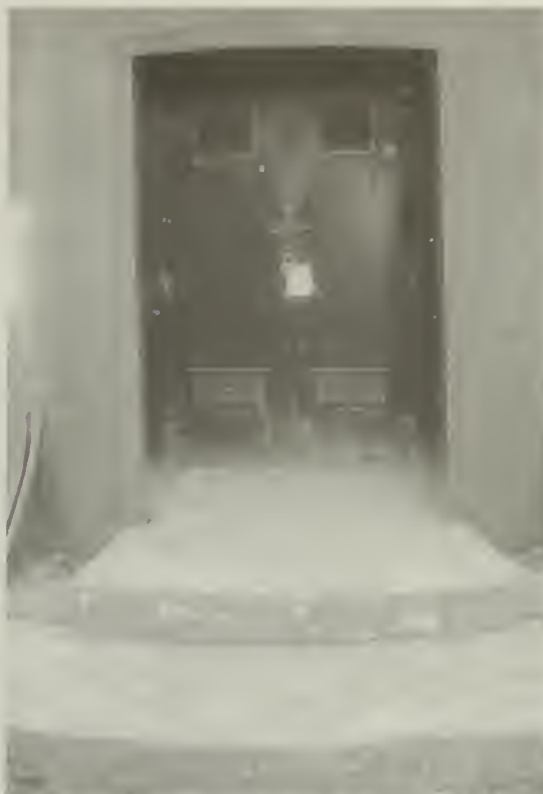
Figure 7. Another variation on the double-leaf, sheet-iron door configuration at the Cape Canaveral Lighthouse, Florida.

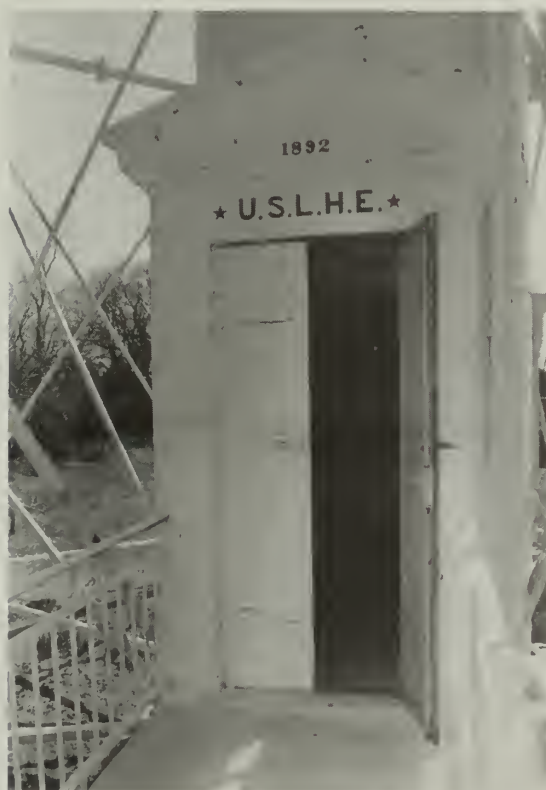
Figure 6. Close-up of the neoclassical, double-leaf, sheet-iron door at the Cape Charles Lighthouse, Smith Island, Virginia.

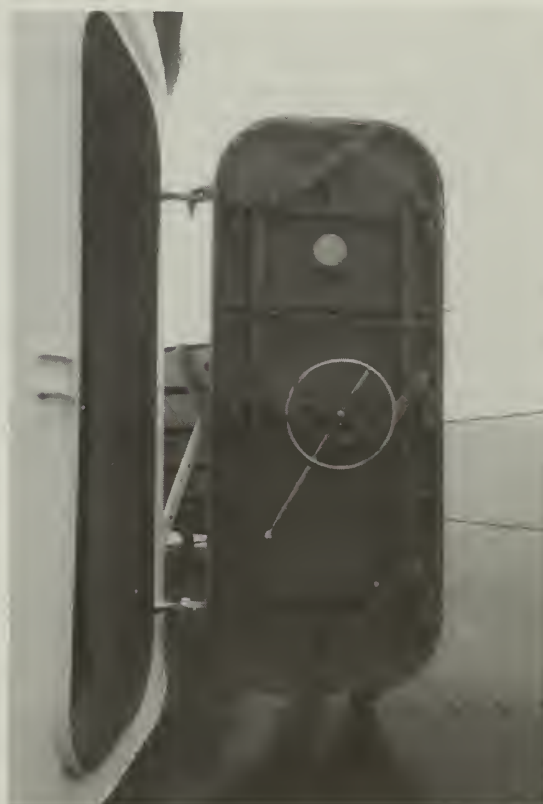
Figure 8. An example of a typical watertight 'ship' style door at Los Angeles Harbor Lighthouse, California.

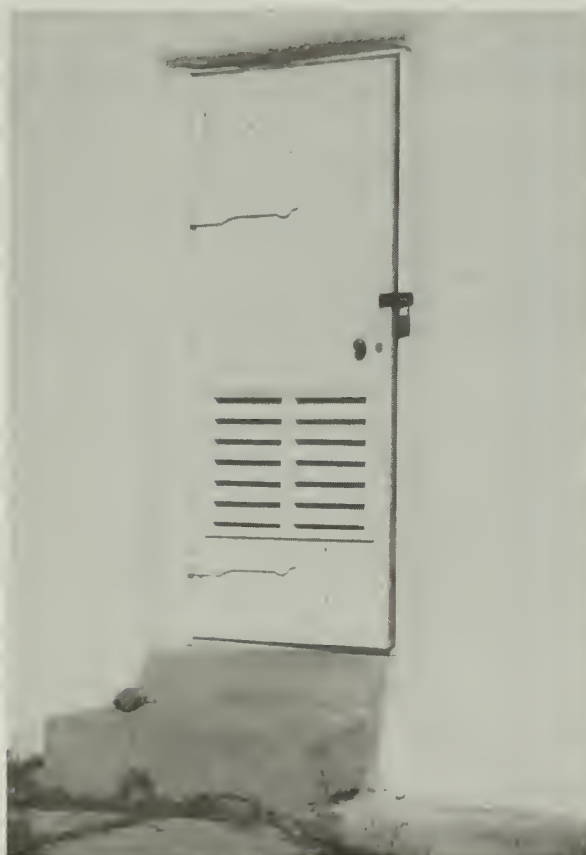
Figure 9. View of the Ocracoke Lighthouse five years after replacement; note rust streaks from nails. This condition indicates the paint coating has degraded to the point where moisture has permeated the surface.

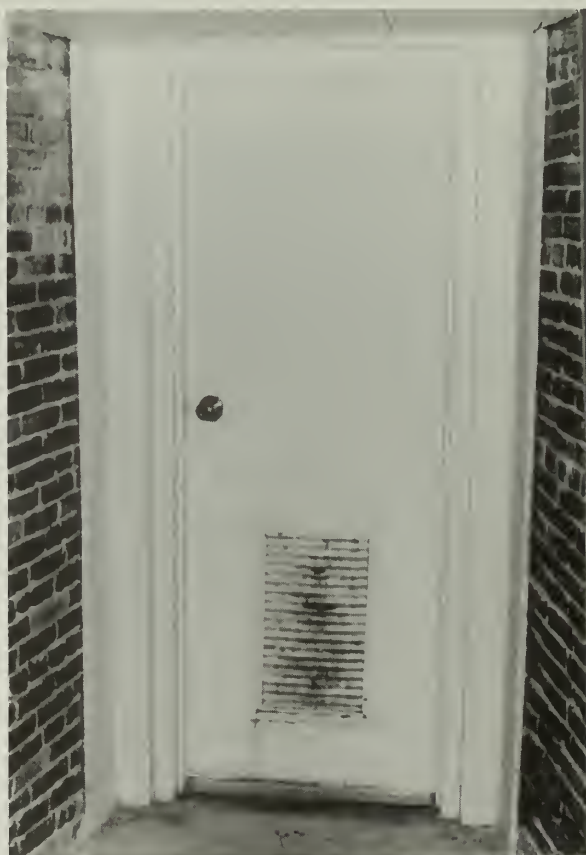
Figure 10. Interior view of the modern metal door at the Ocracoke Lighthouse before its replacement; corrosion like this should be removed and the affected areas treated with a rust-inhibiting coating system.
